SERVICE BULLETIN

SUBJECT: LAMP CIRCUIT COUNTERMEASURE

MODEL: Various Audio Receivers **NUMBER:** SB-9431-B

SUBJECT: Correction of Service Bulletin SB-9002-B **DATE:** September 1994

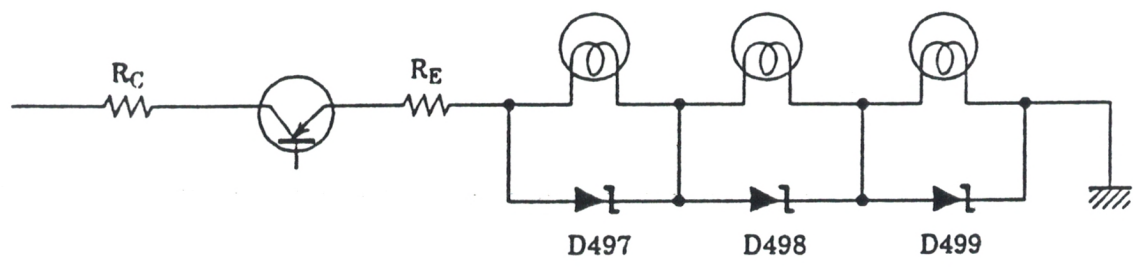
WHEN THE LAMPS BURN OUT, DIODES D497, 498 & 499 SHORT AND BURN THE PCB. TO PRVENT THIS FROM HAPPENING AGAIN, CHANGE THE LAMPS AND THE THREE DIODES. USE THE NEW PART NUMBER SHOWN BELOW AND KEEP THE DIODES 1/4 INCH OR MORE ABOVE THE PCB USING A SPACER (E48269-001) ON EACH LEAD.

Previous MTZ12JC (500mW)
 ↓
 New RD12FB3 (1000mW)

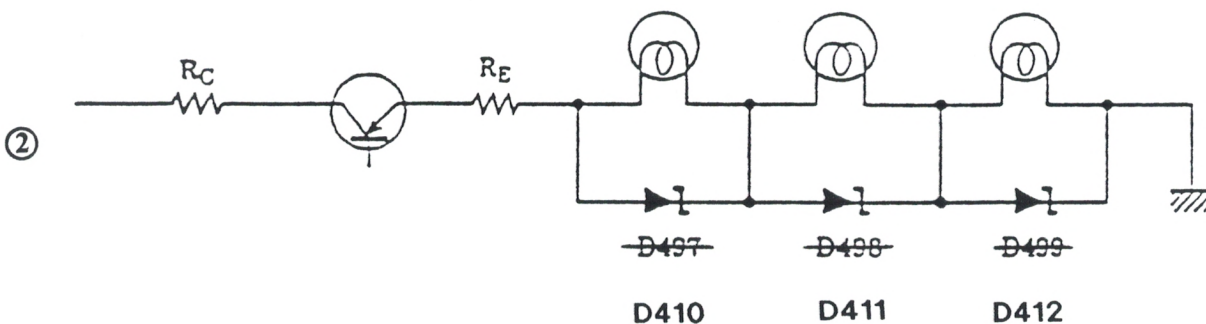
③

- ① When any of the lamps burn out, diodes **D410**, **D411**, and **D412** may short. To prevent this from happening again, change the lamps and the three diodes. Use the new part number shown below and keep the diodes 1/4 inch or more above the PCB using a spacer (p/n E48269-001) on each lead.

Incorrect	Correct
Previous MTZ12JC (500 mW)	Previous p/n MTZ8.2JC (500 mW)
↓	↓
New RD12FB3 (1000 mW)	New p/n RD8.2FB3 (1000 mW)
