# GTE SYLVANIA

## TECHNICAL SERVICE DATA

STEREO HI-FI  
SUPPLEMENT 4 TO  
BULLETIN: R74-3

Table lists all code changes to date on the R74-3,-4 chassis.

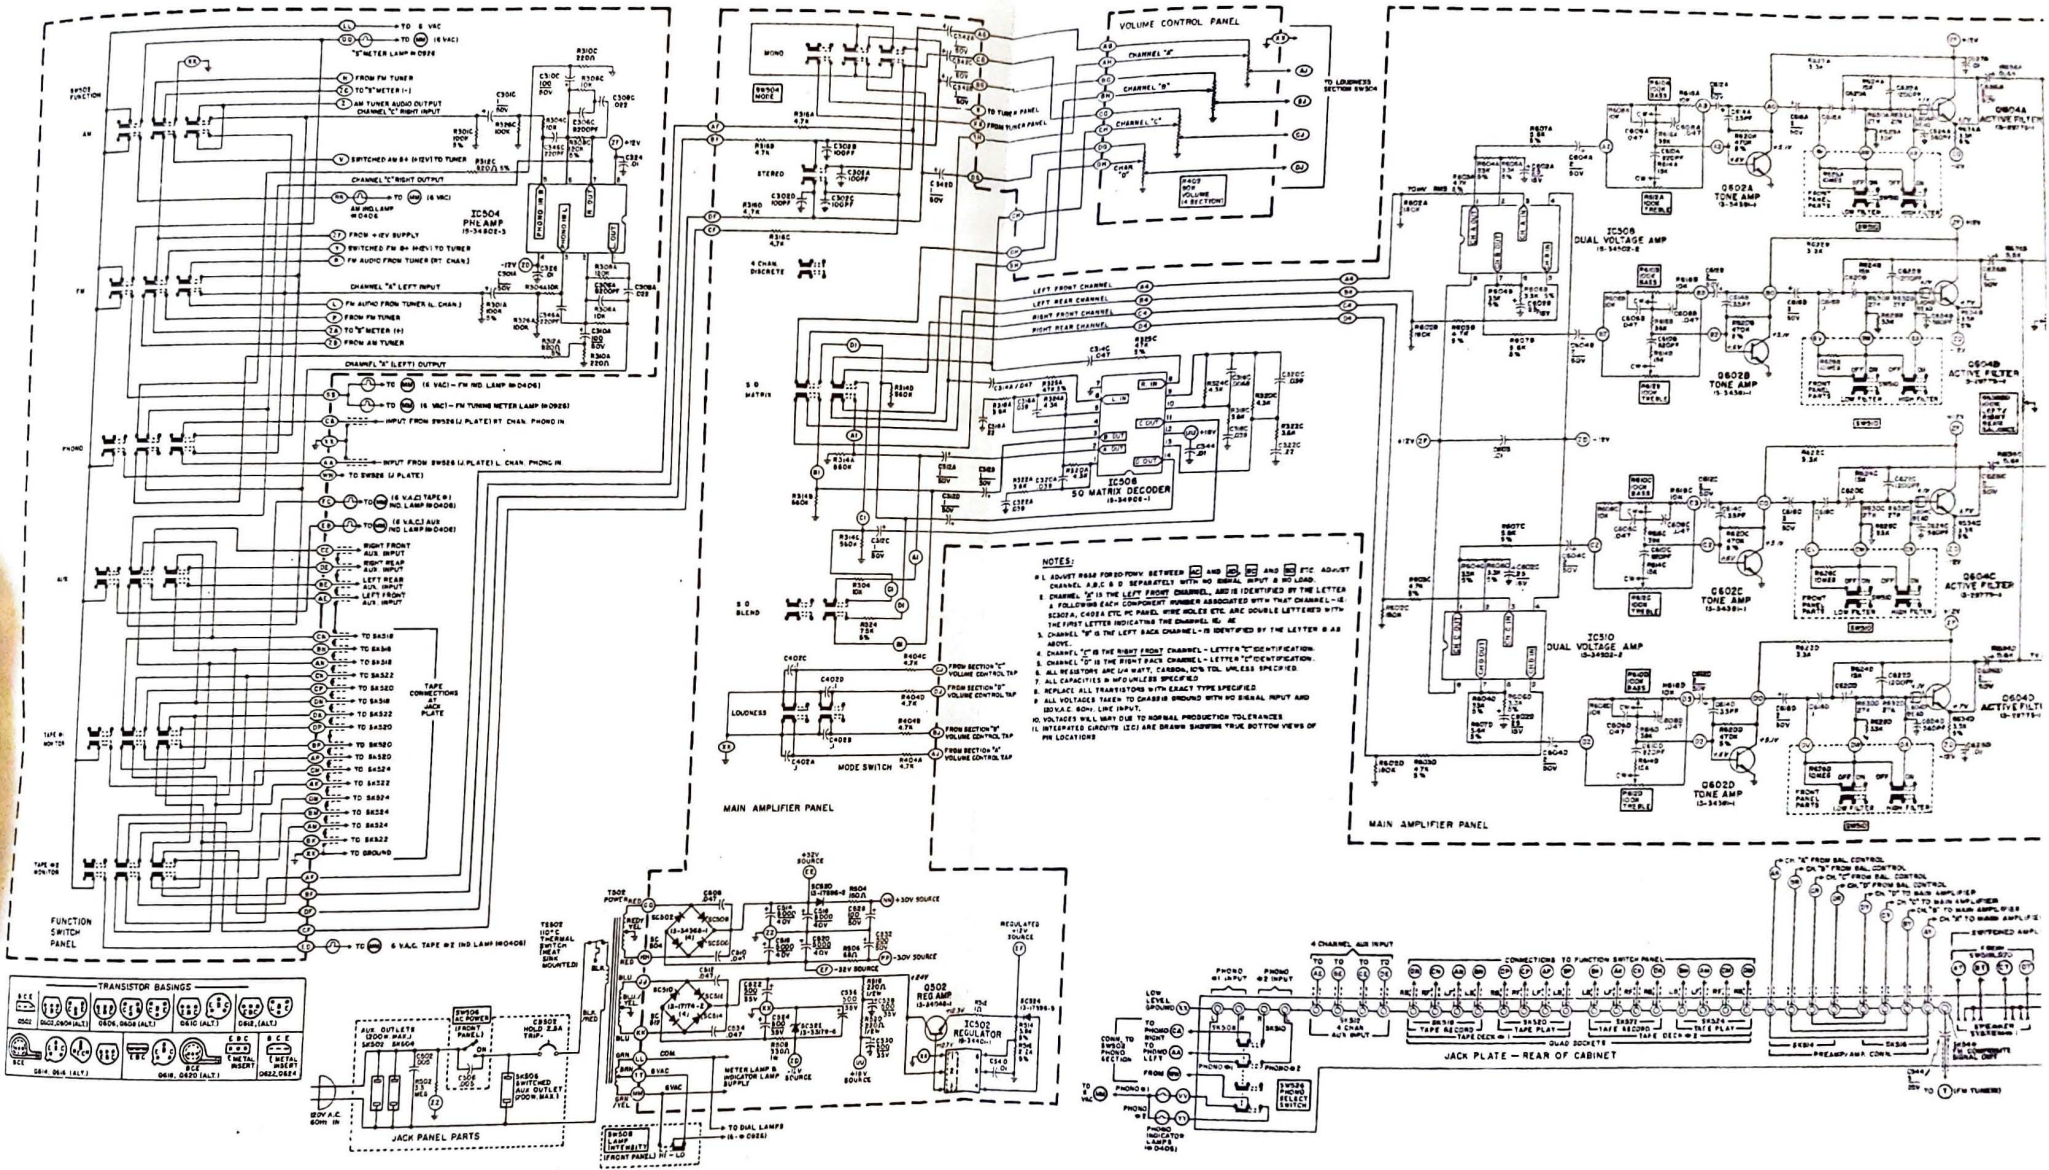
SCHEMATIC DIAGRAM (R74-3 AMPLIFIER)

CODE	CHASSIS	PANEL CODE	DESCRIPTION OF CHANGE
00	ALL	-	INITIAL PRODUCTION.
01	-3		POWER AMPLIFIER OSCILLATION.
01	-4		1) 33pF, N150 capacitors added from Base to Collector of Q606 A,B,C,D on foil side of P/C panel.
02	-3		MULTIPLEX SEPARATION DEGRADES WITH TEMPERATURE CHANGE. 1) Cores replaced in T4 and T6.
02	-4	A	CHASSIS IDENTIFICATION ONLY. To provide a means to identify finished goods built with SQ chips with date codes of 7331 and 7332.
02	-4	B	IMPROVED SPEAKER PROTECTION. 1) CB602 replaced by 02-36800-1 relay panel. 2) C629 removed. 3) R640 removed. 4) C632 value changed to 3.3pF. 5) R639 value changed to 220K. 6) R648 value changed to 10K.
03	-3	-	RELAY TRIPS WHEN TUNING ACROSS FM BAND. (02-36800-1 PANEL REVISION). 1) C1204 value changed to 100MFD/15V - new part number is 41-32477-37. NOTE: All CODE A relay panels with this change prior to CODE B are identified by a RED STRIPE through the identification sticker.

TO COMPLY WITH IHF AND INDUSTRY STANDARDS. 1) BLUE/WHITE/, RED/WHITE, BLUE and RED leads reversed on headphone jacks.  The industry standard is for LEFT channel audio to the TIP of the headphone plug, and RIGHT channel audio to the RING of the plug.

CODE	CHASSIS	PANEL CODE	DESCRIPTION OF CHANGE
03	-4	B	<p>POWER AMP NOISE PICKED UP IN AM MODE.</p> <ol style="list-style-type: none"> <li>1) C114 value changed to .05, 50V.</li> <li>2) C529 (.22, 150V) added from amplifier end of +32V buss to ground on foil side of P/C panel.</li> <li>3) C629 (10pF, NPO) added between Base and Collector of Q606 on foil side of panel.</li> </ol>
04	-3	-	<p>RF PICK-UP IN PHONO PREAMP</p> <ol style="list-style-type: none"> <li>1) C304 removed.</li> <li>2) C346A (1000pF, Z5P) added between pins No. 2 &amp; 3 of IC504.</li> <li>3) C346C (1000pF, Z5P) added between pins No. 5 &amp; 6 of IC 504.</li> </ol> <p>TO ELIMINATE POP WHEN SWITCHING FROM FM TO AM.</p> <ol style="list-style-type: none"> <li>1) C46 removed.</li> <li>2) R302A, C removed.</li> <li>3) R326A, C value changed to 100K.</li> <li>4) R63 (100K, 5%) added from wire hole L1 to ground.</li> <li>5) R65 (100K, 5%) added from wire hole R1 to ground.</li> <li>6) R149 (100K, 5%) added from square wire pin Z to ground.</li> <li>7) R301A (100K, 5%) added from + end of C301A to ground.</li> <li>8) R301C (100K, 5%) added from + end of C301C to ground.</li> </ol> <p>TO ELIMINATE POP WHEN SWITCHING FROM FM TO PHONO.</p> <ol style="list-style-type: none"> <li>1) C72 value changed to 1MFD/50V.</li> <li>2) C74 value changed to 1MFD/50V.</li> </ol> <p>TO FACILITATE BOARD ASSEMBLY.</p> <ol style="list-style-type: none"> <li>1) C108 (10MFD/15V Electrolytic) added from junction of R112, R114 to ground.</li> <li>2) Q604 part number changed to 13-29775-1.</li> </ol> <p>TO REDUCE SWITCH POP.</p> <ol style="list-style-type: none"> <li>1) C604 value changed to 2MFD/50V.</li> <li>2) R314 value changed to 47K, 5%.</li> <li>3) R607 value changed to 5.6K, 5%.</li> <li>4) R620 value changed to 470K, 5%.</li> <li>5) R634 value changed to 3.3K, 5%.</li> </ol>

04	-4	B	<p>FET RELIABILITY IMPROVEMENT.</p> <ol style="list-style-type: none"> <li>1) Q2 part number changed to 13-34378-3.</li> </ol>
