*Phase Linear 400*

MODEL 400  
POWER AMPLIFIER

Service Manual

prepared 6/76  
1st revision 6/80  
2nd revision 6/81

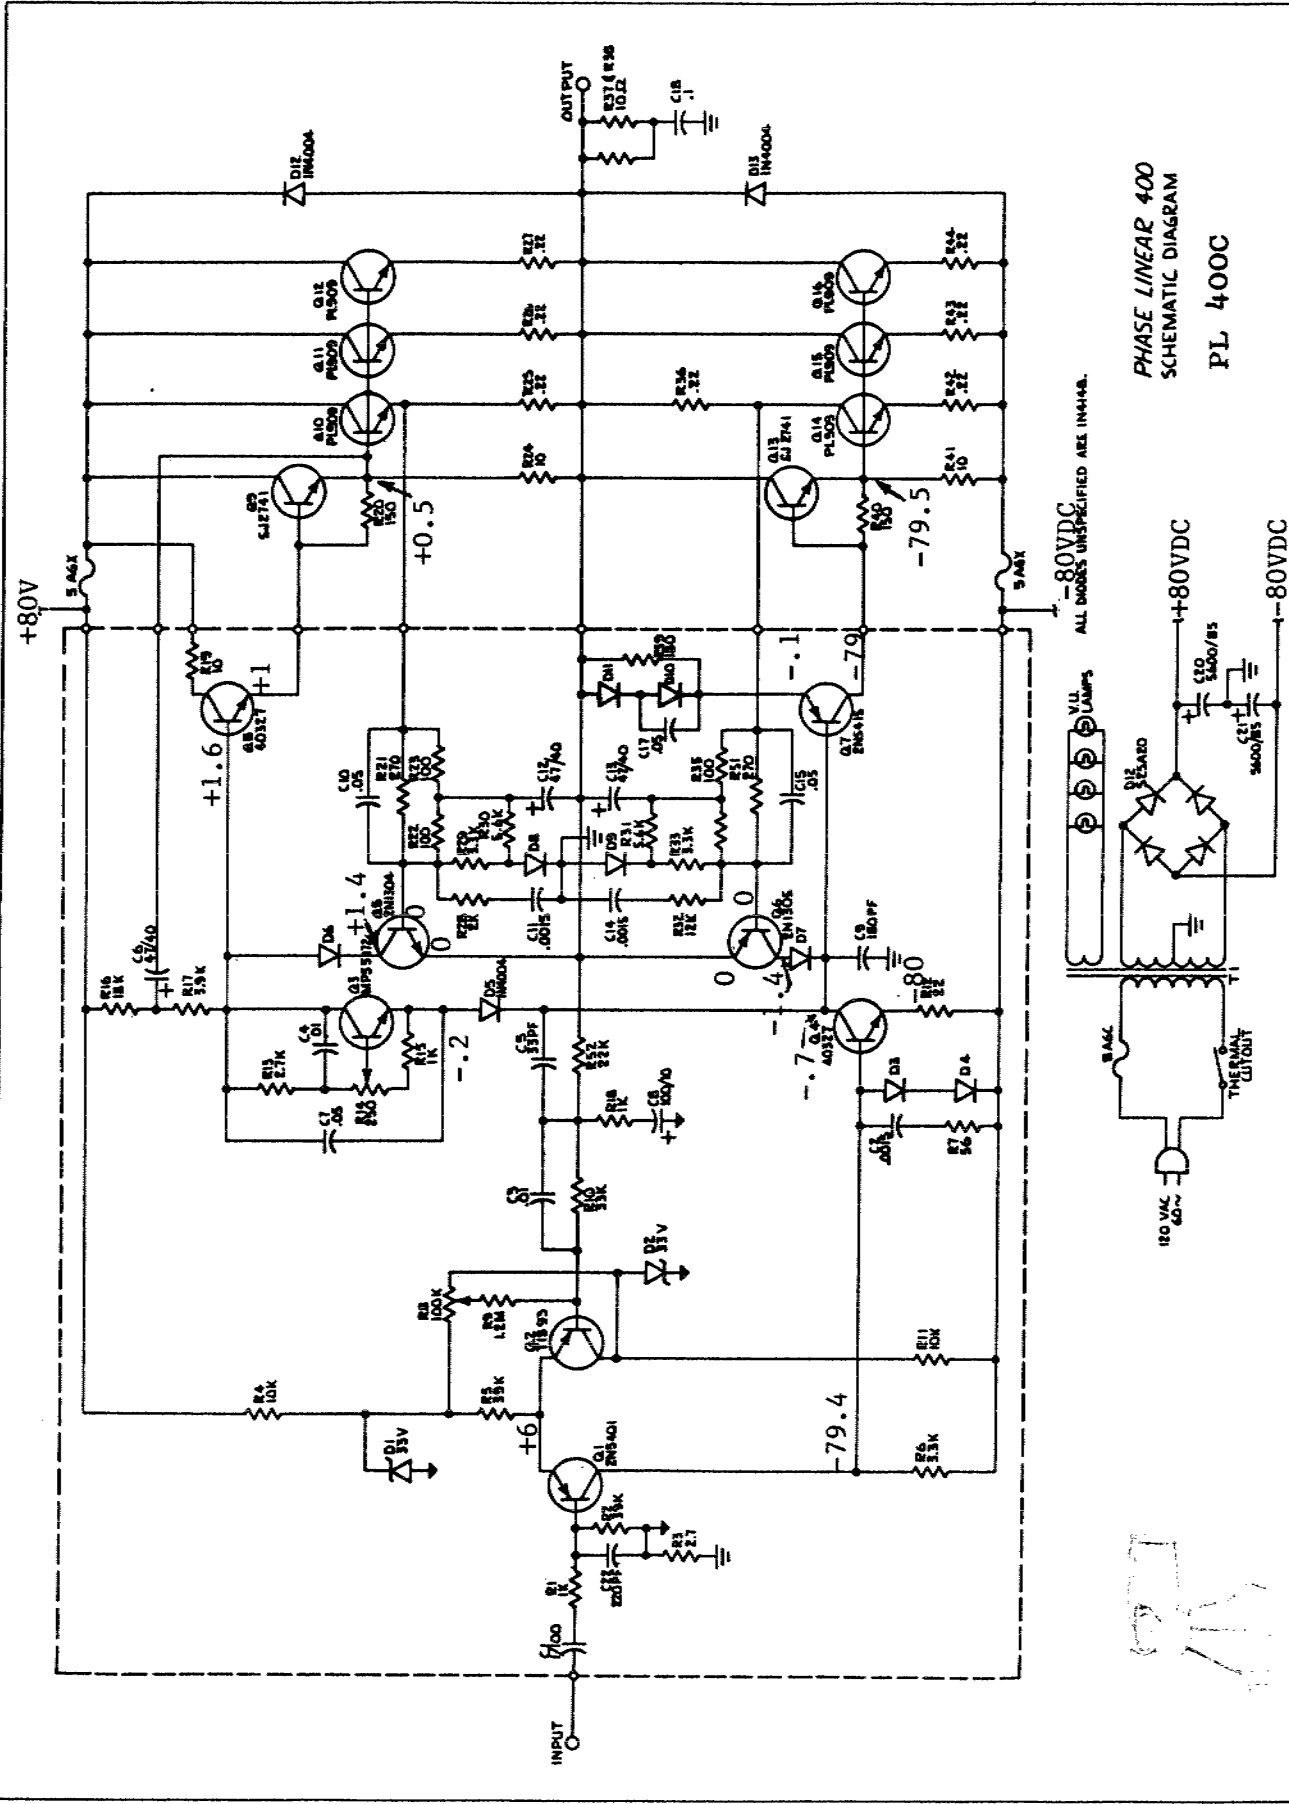
PHASE LINEAR 400  
SCHEMATIC DIAGRAM  
PL 400C

Input signal is applied to the base of Q1. The output of the differential pair comprised of Q1 and Q2 is applied to the base of Q4. Q4 provides the final voltage gain to drive the pre-driver transistors Q7 and Q8. The PNP predriver Q7 serves as a phase inverter to drive the negative output driver transistor Q13. The emitter of Q13 drives the paralleled emitter follower output transistors Q14, Q15 and Q16. The positive half of the signal is amplified by emitter follower Q8 which in turn drives the paralleled outputs Q9, Q10 and Q12.

Forward bias is generated by bias regulator transistor Q3. R14 adjusts the slight amount of forward bias necessary to provide a few milliamps of idling current in the driver transistors which minimizes crossover distortion.

The protection circuit consists of Q5, Q6 and their associated R-C and diode networks. If the output current flowing through R25 and R36 becomes dangerously large, capacitors C12 and C13 acquire a voltage through R23 and R35 to cause Q5 and Q6 to turn on. Drive current is then shunted through D6 and Q5 around the predriver Q8, preventing an uncontrolled increase in output current. This prevents Q9 from driving the load. D12 and D13 are flyback diodes which prevent overvoltage from appearing across the output transistors in the event an inductive load is switched.

ALL DIODES UNSPECIFIED ARE 1N4448.

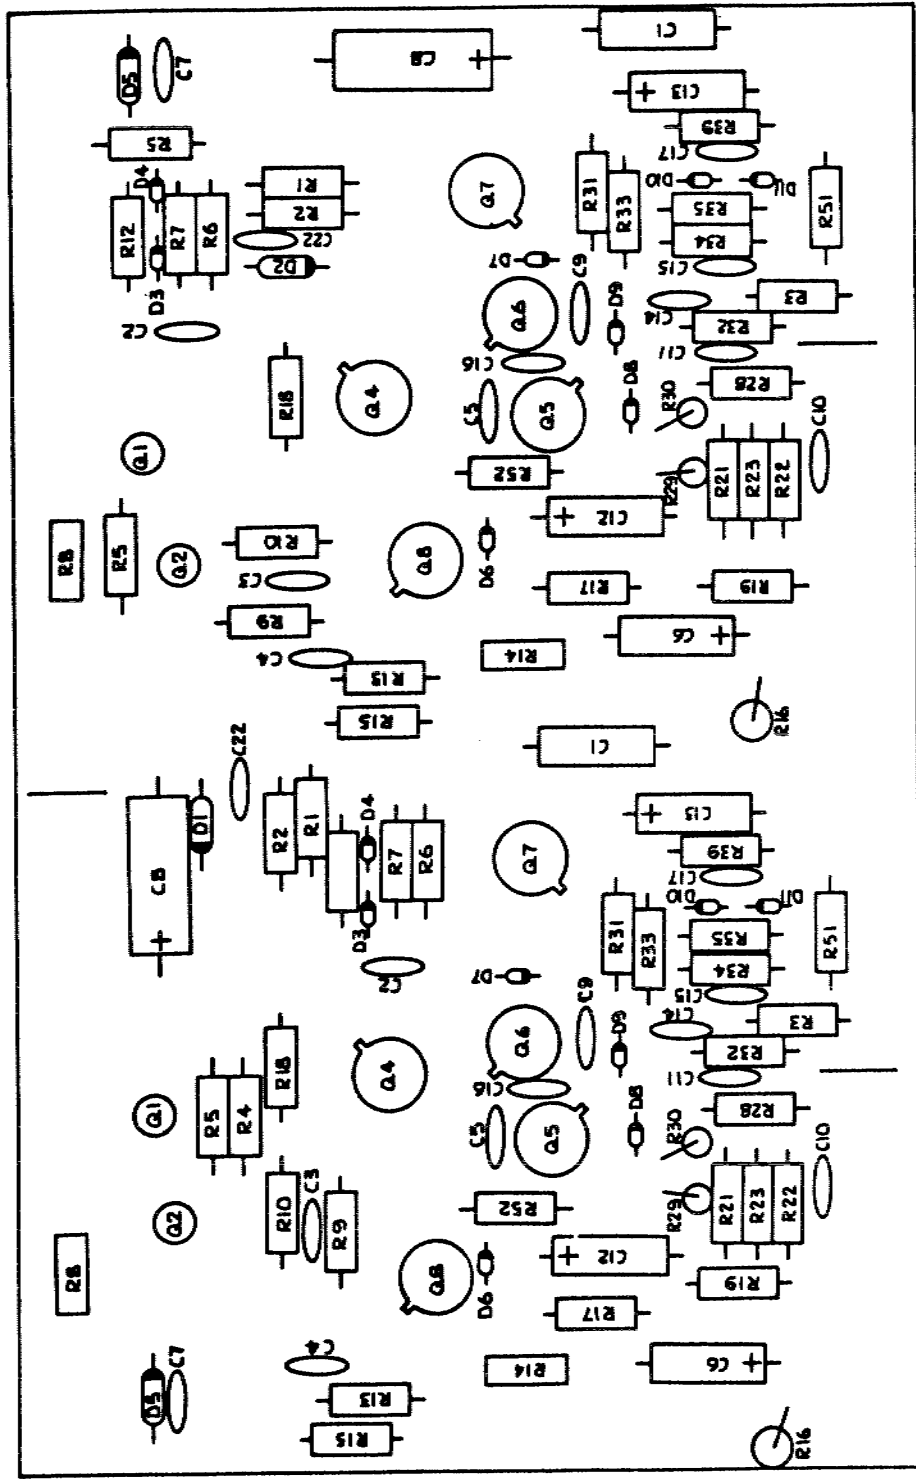
PHASE LINEAR 400  
 PCB ASSEMBLY  
 PL 400C

NOTE: Test measurements are made with no inputs or outputs connected to the amp.

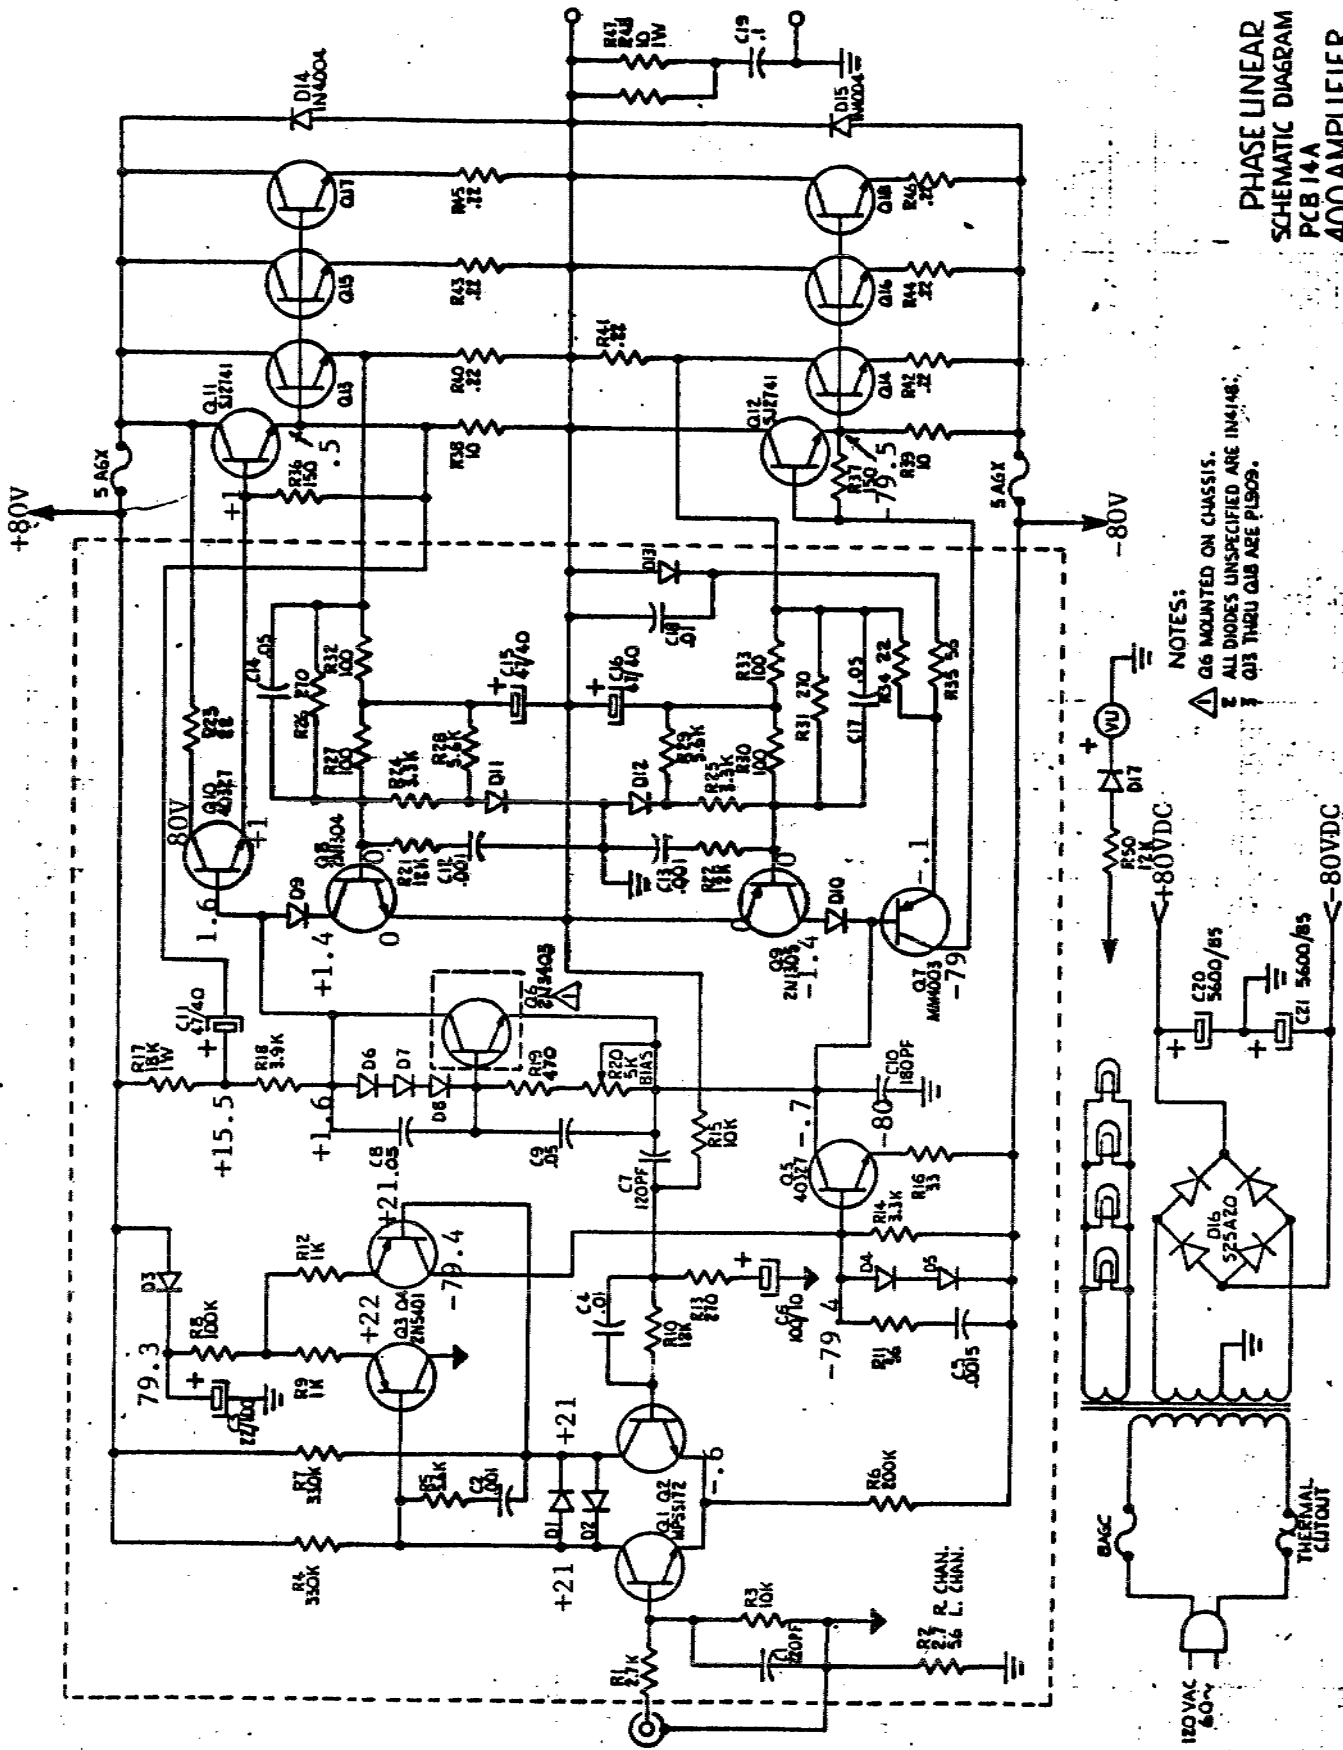
PHASE LINEAR  
SCHEMATIC DIAGRAM  
PCB 14A  
400 AMPLIFIER

Input signal is applied to the base of Q1. The output of the differential pair comprised of Q1 and Q2 is applied to the second differential pair Q3 and Q4. This second differential pair provides single-ended output which is applied to the base of Q5. Q5 provides the final voltage gain to drive the predriver transistors Q7 and Q10. The PNP predriver Q7 serves as a phase inverter to drive the negative output driver transistor Q12. The emitter of Q12 drives the paralleled emitter follower output transistors Q14, Q16 and Q18. The positive half of the signal from Q5 is amplified by emitter follower Q10, which in turn drives the paralleled outputs Q13, Q15 and Q17 through output driver Q11.

Diodes D6-D8 provide forward bias to the output bias regulator transistor Q6. R20 adjusts the slight amount of forward bias necessary to provide a few milliamps of idling current in the driver transistors which minimizes crossover distortion.

- NOTES:
- △ G6 MOUNTED ON CHASSIS.
  - ⊗ ALL DIODES UNSPECIFIED ARE 1N4148.
  - ⊚ Q13 THRU Q18 ARE PL509.

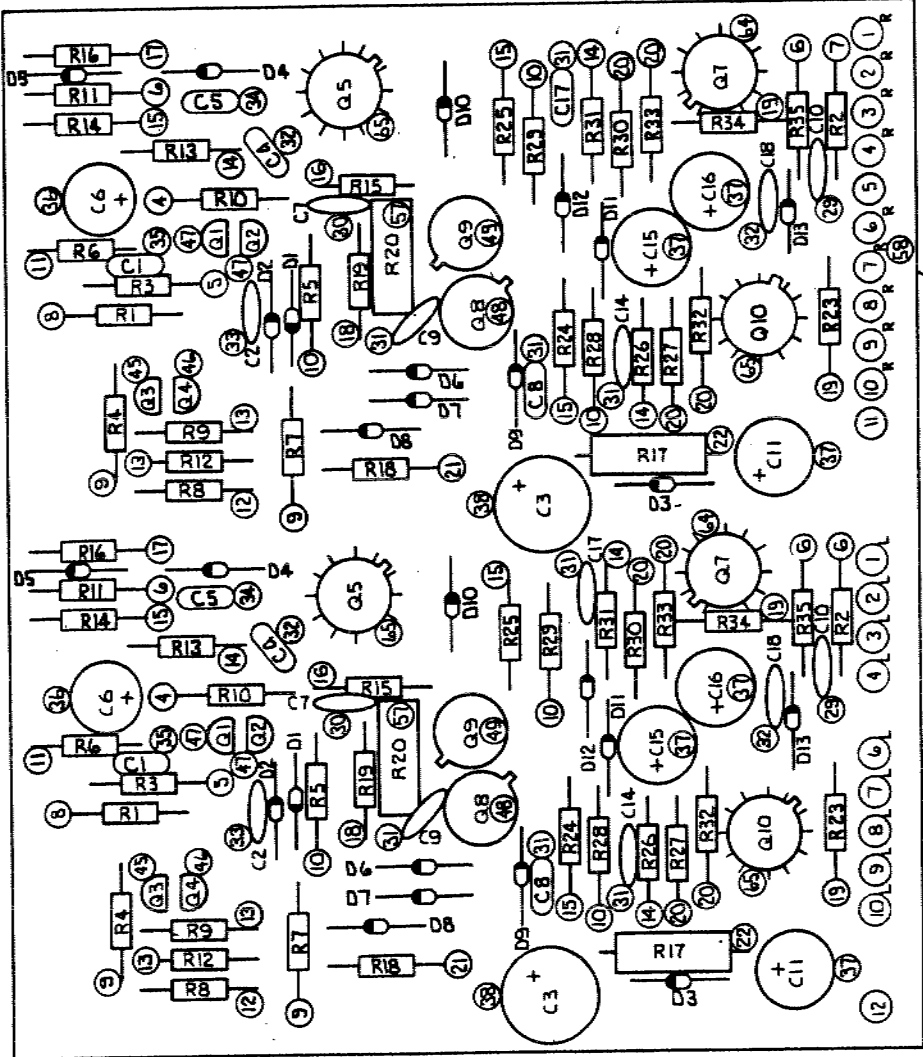
O3 ASSY 400 POWER AMP PCB. PL14B.

NOTES: UNLESS OTHERWISE SPECIFIED  
DIODES ARE IN4148.

- C- SAME AS D EXCEPT C1 IS 100PF/100
- D- SAME AS O1 EXCEPT EXTRA HOLES ARE ON PCB. AND ADD 1 JUMPER ON PAD 11.
- O1- SAME AS O2 EXCEPT Q1 & Q2 ARE MP5512Z.
- O2- SAME AS O3 EXCEPT R16 IS 200K & C5 IS .0015PF.
- O3- SHOWN

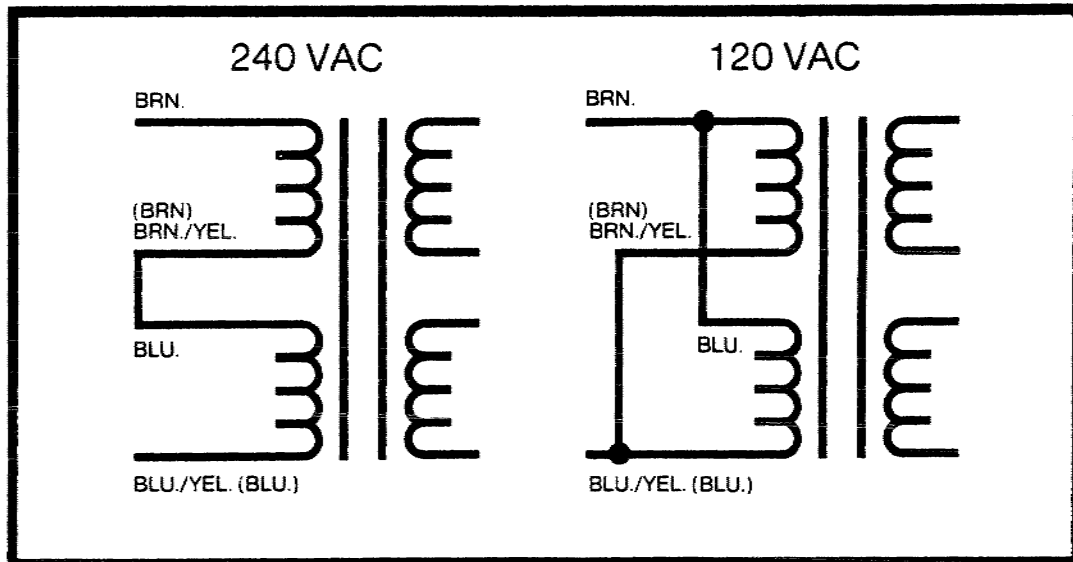
Once a model 400 is equipped with the dual-primary transformer, or for those few units which are presently equipped with one, the following is a diagram which explains the proper wiring for either 117/120VAC or 220/240VAC operation:

IF THE PRIMARY VOLTAGE IS CHANGED, THE LINE FUSE MUST BE CHANGED AS FOLLOWS:

120 VAC: Use 10 AMP, Type AGC

For most model 400 amplifiers the only means of changing line voltage operation is with the use of a step-up or step-down external transformer, or by changing the power transformer on the amplifier. Dual-primary power transformers are available from the factory as part number 125-0033. Contact the factory service department for current prices and availability.

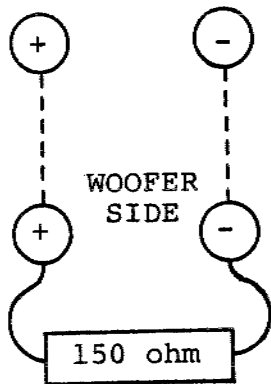
Due to the crossover design of the Watkins(TM) Woofer system, a very large capacitance value (1000-2000 uF) is seen by the amplifier. Normally this capacitance is not a problem, however under some operating conditions trouble can occur. Avoid turning off the amplifier and turning it back on before the crossover completely discharges (usually 1-2 min.). The amplifier charges the capacitors at turn-off, and upon turn-on they discharge back into the amplifier, causing offset and/or damage to the amplifier and/or speaker. To bleed off this charge a resistor shunt at the speaker terminals for the woofer is recommended (see diagram below). The value for the resistor is 150 ohm/10 watt.

(10 watt)

--- BI-AMP LINK
